# A Study on Aircraft Accident: The United Airlines flight 173

<sup>1</sup>Ananshi Arora, <sup>2</sup>Vijayalakshmi Bharathi K

<sup>1</sup>Student, <sup>2</sup>Assistant Professor

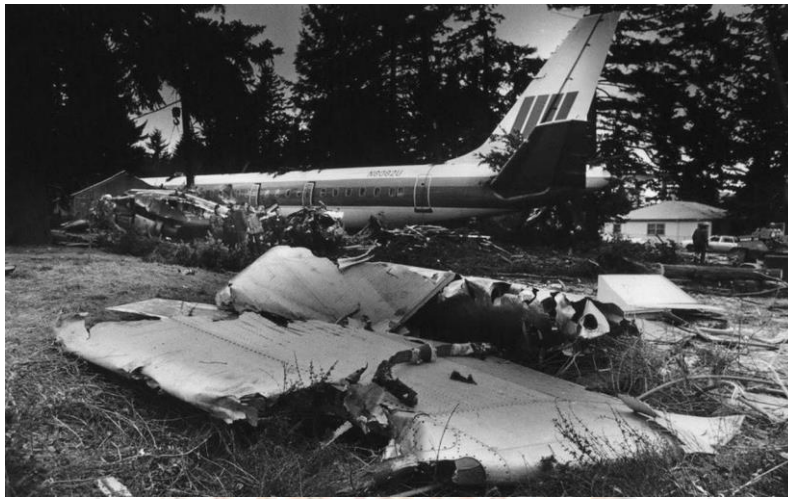
Fig 4 [7]

There was a chance that some people would survive the accident. It was established that the 10 people who passed away as a result of the accident were located between the control and maintenance stations in the cockpit and the roof of the fifth row in the passenger compartment. When the emergency was declared, all of the bodies of the people who had passed away were located on the right side of the passenger cabin. The section of the airplane was completely destroyed as a result of the accident, which occurred earlier. The passengers who were located in the right upwards segment of the cabin, which was situated near to a section of the fuselage that appeared to have been pierced by a large tree, were the ones who suffered the most severe injuries. The passengers who were located in the left rear portion of the cabin also suffered serious injuries. These folks were seated in quite close proximity to the ones who ultimately passed away as a consequence of the injuries they sustained. A number of passengers who suffered significant injuries were sat in the rear cabin, which is located close to the leading edge of the wings. In this region of the aircraft, the fuselage had been breached, and both the floor and the seats had been damaged.

In under two minutes, everyone was safely out of the plane. Behind row 6, there was minimal damage to the cabin's furnishings, with the exception of a few seats that had been pulled free from their floor attachments. During the necessary evacuation, the emergency lights provided sufficient illumination.
