Taxation of cracks on concrete bridges using image dispensation supported by laser scanning study

¹J.Sree Naga Chaitanya, ²Dr.K.Chandramouli, ³Dr. Shaik.Bifathima, ⁴Shaik Naseema

^{1,2,3&4} Department of Civil Engineering, NRI Institute of Technology, Visadala (V), Medikonduru (M), Guntur, Andhra Pradesh, India.

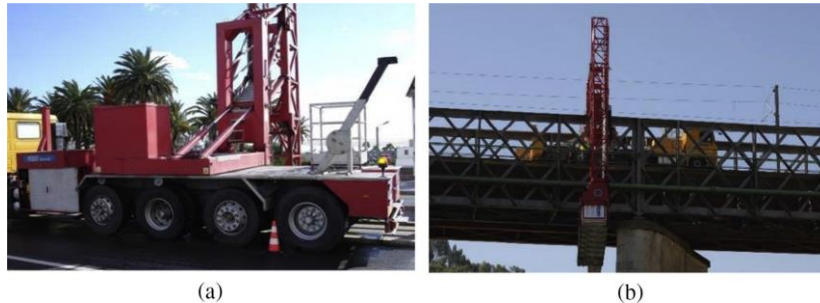
Fig. 2. Under-bridge truck: (a) parked on top of the bridge deck; and (b) platform to access below the bridge deck and the supports.

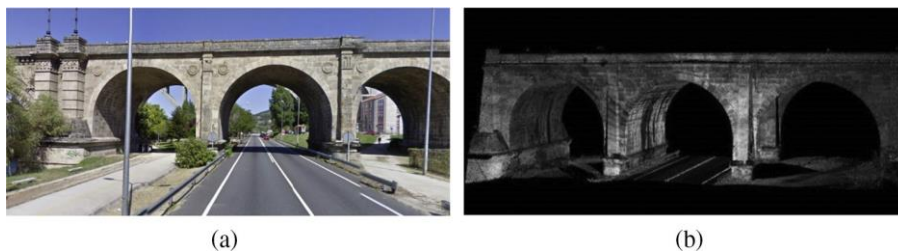
Fig. 3. New Bridge of Ourense, Spain: (a) overview; (b) 3D geometric model (point cloud) obtained by laser scanning.

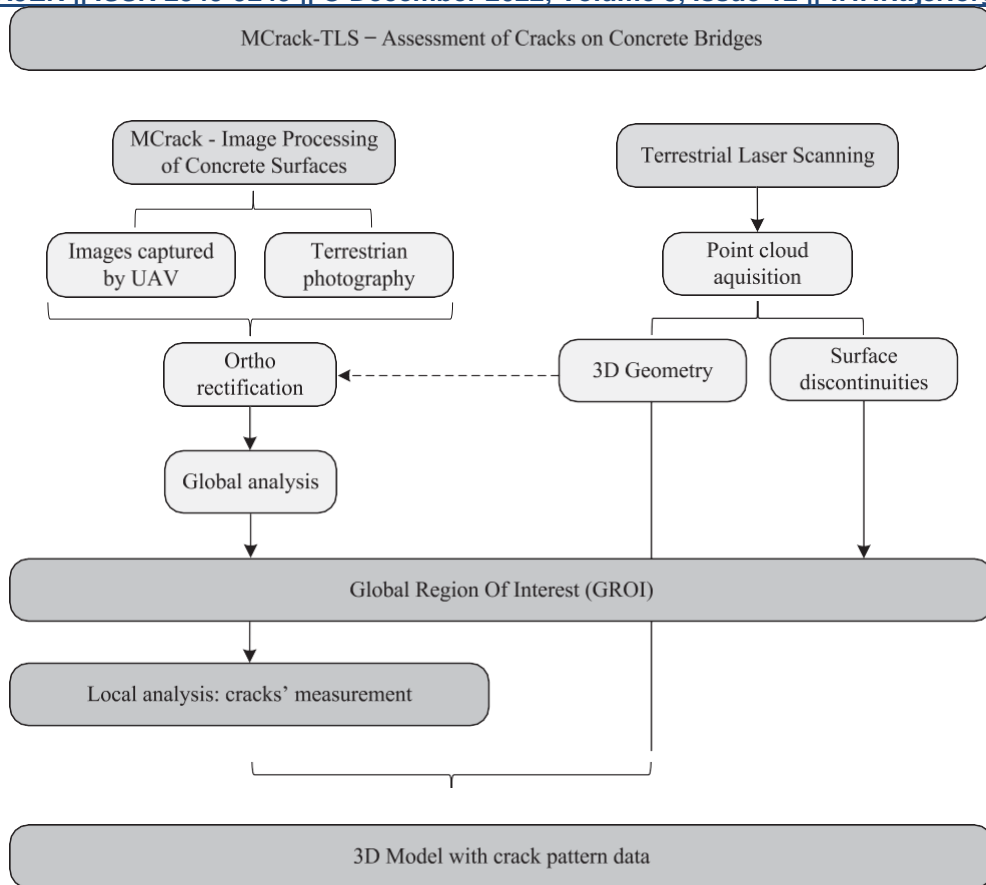
Fig. 5. Flowchart of the ‘MCRack-TLS’ method.

The flowchart of the method 'MCRack-TLS' Assessment of Cracks on Concrete Bridges is presented in Fig. 5. The method is organized in two major categories: (1) TLS which, initially, operates independently, and (2) application of image processing and analysis based on improving and merging two methods previously developed [3,20] that starts next, and then is performed simultaneously. Except for the point cloud generated by laser, the algorithms were implemented in Matlab environment [22].

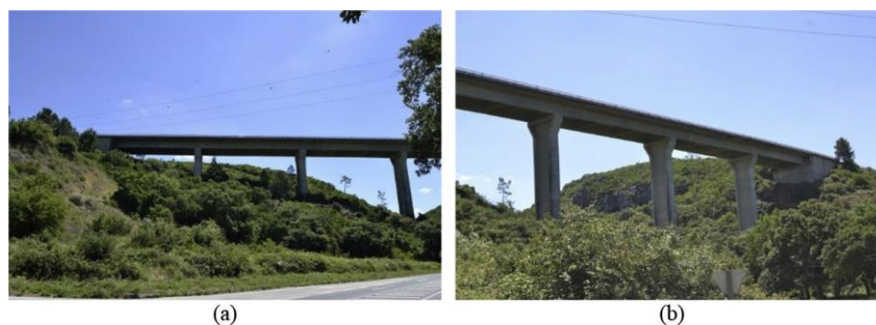
Fig. 10. Viaduct of IC2, over EN114, Rio Maior, Portugal: (a) North part; (b) South part.

The viaduct of IC2 (km 74 + 040), over EN114, is located near the city of Rio Maior, Portugal. The viaduct comprises six spans and has a total length of 224 m and a width of 16.5 m. The longest span has a length of 40 m and the tallest column has a height of 32 m (Figs. 9 and 10). In order to validate the method herein presented, it was applied to the North abutment zone. A laser scanning and image acquisition survey were planned.

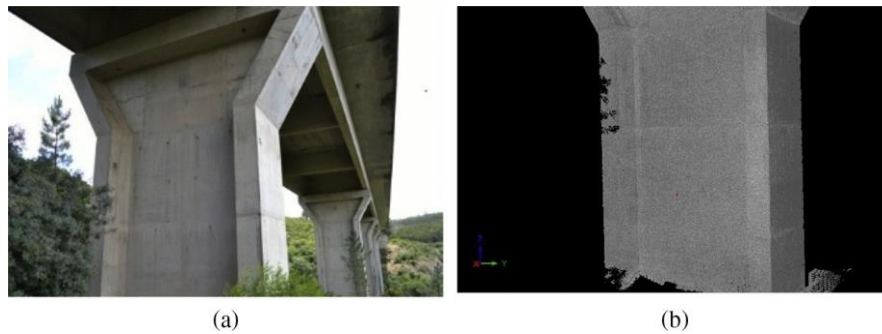
Fig. 13. Geometric survey with laser scanning of the North face of column P1 (station #2): (a) photo of the analyzed area; (b) point cloud.

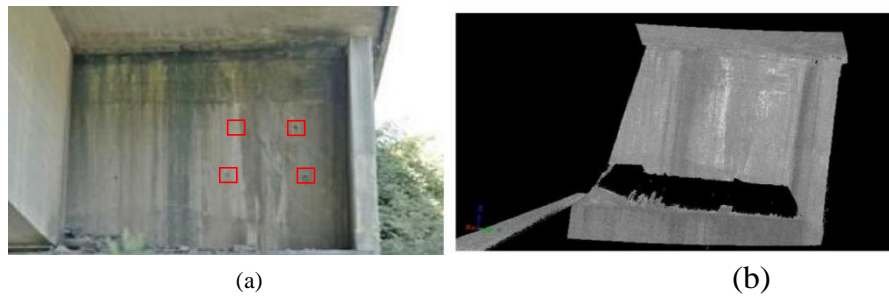
Fig. 14. Geometric survey with laser scanning of the wall of the North abutment, East side (station #3): (a) photo of the analyzed area and reference points; (b) point cloud.

In this particular case, the reference targets selected are the centers of circular holes in the concrete surface (Fig. 14a), probably resulting from shoring of the formwork during the construction process. The coordinates obtained by TLS are later on used for image rectification. As expected, the procedure applied to identify discontinuities by TLS was not effective for the evaluation of cracks in the wall of the North abutment. Due to the reduced resolution of the laser, the procedure could not identify relevant discontinuities, since the laser beams don't penetrate into the cracks these could not be identified. On the contrary, the global processing of the orthorectified images allowed the identification of the crack in the analyzed area. An unsupervised classification using ISODATA algorithm was applied [20,27]. However, the high density of dirt and moisture stains on the concrete surface can cover some parts of the cracks. In some cases, the stains in the upper area of the crack turned difficult to clearly identify the crack borders (Fig. 16). This occurred regardless of the algorithms used in the multispectral analysis. In these situations, the semi-automatic procedure, aiming at defining crack segments with distinct orientations, was applied: four points (red dots in Fig. 16b) were selected to define the vertical coordinate and thus to define the boundary of five local regions of interest (LROI).

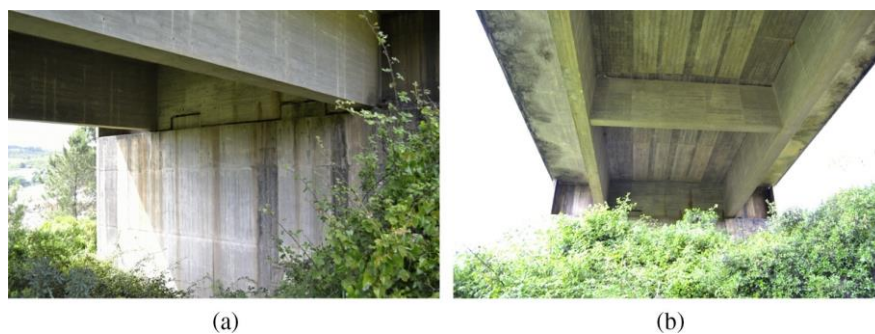
Fig. 15. Details of the north abutment: (a) East view; (b) bottom view.

The image survey requires access zones for the positioning of photographic stations and, due to the large size of the structure, the use of different focal lengths to survey all key structural members. The north abutment was surveyed with a focal length of 300 mm at 20 m of distance, resulting in a spatial resolution of 0.22 mm/px (Fig. 15).
